Fatigue Failure of a Pressing Machine

Abstract: This article presents an analysis of the causes of a fatigue crack in the guide bar of a pressing device. The detailed analysis included the analysis of a material's microstructure and its cyclic properties. Direct measurements of the strains during operation allowed the nominal loading process in the critical cross-section of the press subassembly to be obtained. The notch effect of the inner thread of the guide bar was analyzed using a precision FEM (finite element method) model and was followed by the transformation of the nominal loading into the notch root. A methodological approach was formulated based on the analyses made, which lay in the statistical interpretation of the factors leading to an identification of the cause of an early fracture.

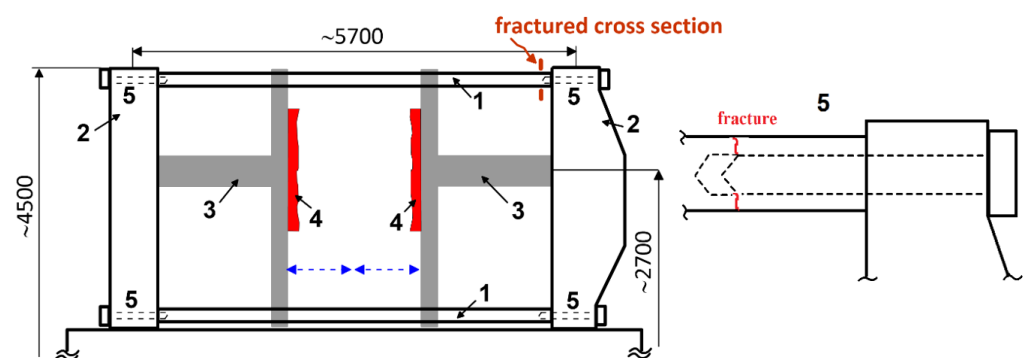
Figure 1. Scheme of the main frame of the pressing machine for production of car tanks. 1—guide bars, 2—massive stiff vertical frame members, 3—hydro motor, 4—former, 5—M80 bolts (detail), $l \approx 520$ mm.

After about 500,000 work cycles, the fracture occurred in the upper guide bar (see Figure 1). The fatigue crack initiation was in the internal thread of the guide bar in the cross-section between the bolt end and the bottom of the threaded rod guide opening. The fracture surface appearance displayed in Figure 2 demonstrates the high rate of fatigue crack propagation across the overall cross-sectional area. The residual fracture of the whole cross-section is only about one-third of total cross-sectional area.

The fatigue crack initiation site was at the root of the internal thread (the first engaged thread, see Figure 1). The criticality of this cross-section was predetermined by the change in cross-sectional stiffness at the location between the end of the bolt and the bottom of the threaded hole (Figure 2). In this area, the annular cross-section caused additional bending loading under the tensile loading from the prestressed bolt and the pressing force developed by the hydraulic cylinder. The resulting value of the stress (from the bolt pre-tension, additional bending moment, and pressing force) had to be recalculated (transformed) into the notch root of the thread. The effective method for such transformation, applicable in engineering practice, is Neuber's method [12,13]. The equation below requires the knowledge of nominal stress/strain value σ_n/ε_n , deformation as well as the effective notch coefficient of the thread root in the hole of the guide bar:

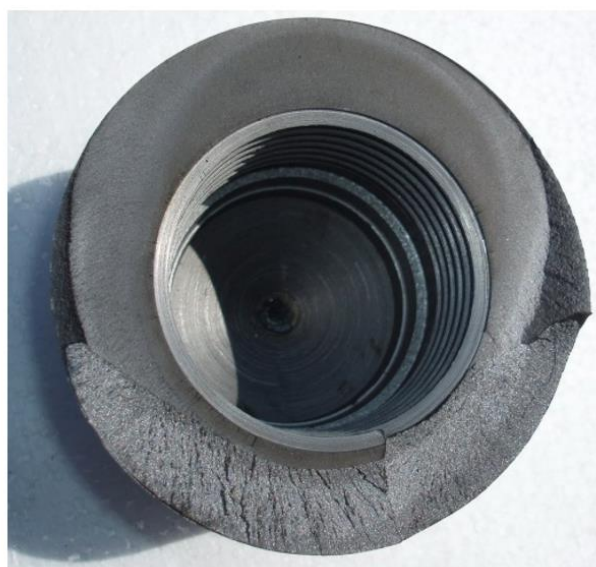
Figure 2. Fracture surface.

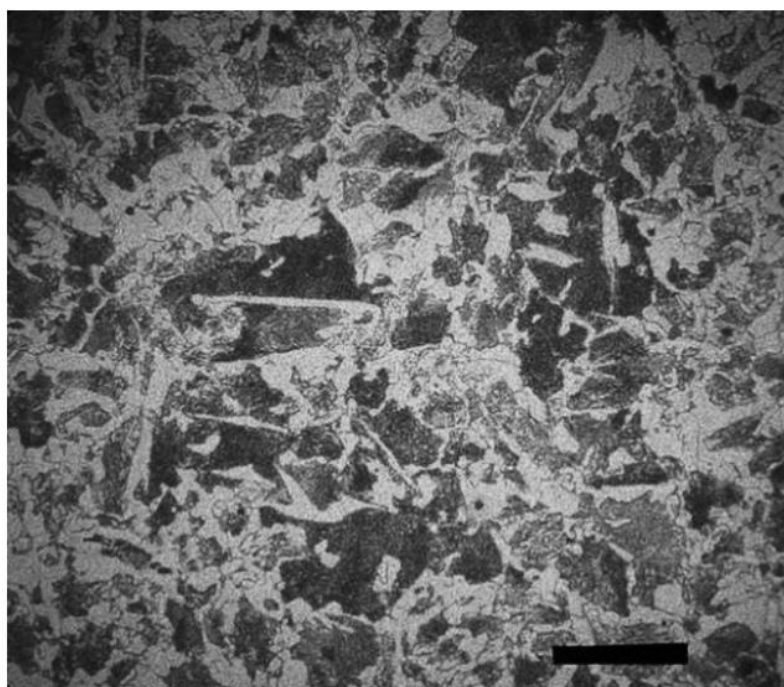
- The material is non-eutectic steel with a ferritic–pearlitic structure which has not been heat-treated.
- Carbon content is $0.45 \div 0.48\%$.
- The possible alloying element is chromium (in the unprocessed state, it practically does not have any impact on the strength and deformation properties of the steel).
- The microstructure of the material is highly homogeneous without structural debris, massive deposits, cracks, burnt oxides, etc.
- In view of the small number of deposits, it can be assumed that the steel has a low sulphur and phosphorus content and was obtained by a two-stage metallurgical treatment.
- The structure of the steel does not contain any structural regions that would serve as local initiators of the origin and growth of the fatigue crack.

Figure 3. Metallographic facet of the steel (magnified 250 times, etched in nital).

While assessing the causes of premature fracture of the guide bar, it was necessary to analyze the material at the fracture site and the working cycles of the device in terms of stresses acting in the cross-section where the fracture occurred. A sliver of base material directly cut out from the guide bar in the fracture site was selected for metallographic analysis of its microstructure and hardness measurement. By mechanical splitting, subsequent grinding, and fine polishing, the microscopic structure was enhanced after etching (Figure 3).

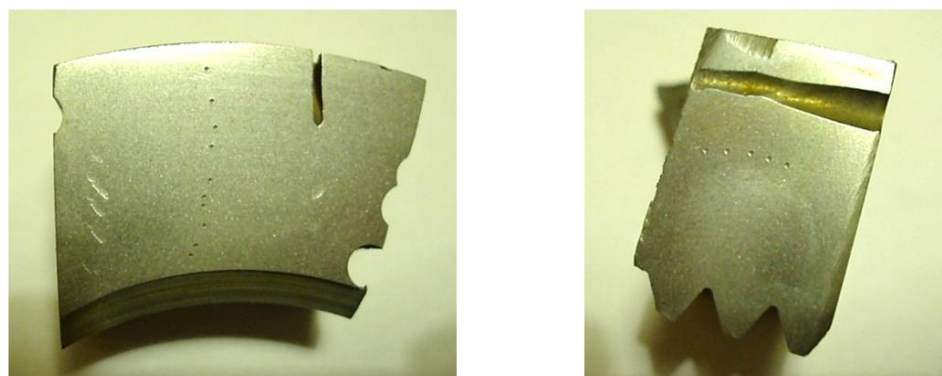
The measured hardness values (Figure 4) with minimal scattering are confirmed by the conclusions of the metallographic observation of the structural homogeneity of the steel under consideration and its sufficient plastic properties (ductility). The hardness determined for steel strength is about 495–530 MPa. The fatigue limit of such material can be calculated by methods [8,9] to an approximate value of 220 MPa.

Figure 4. Hardness measurements at the site of the guide bar crack in both directions.

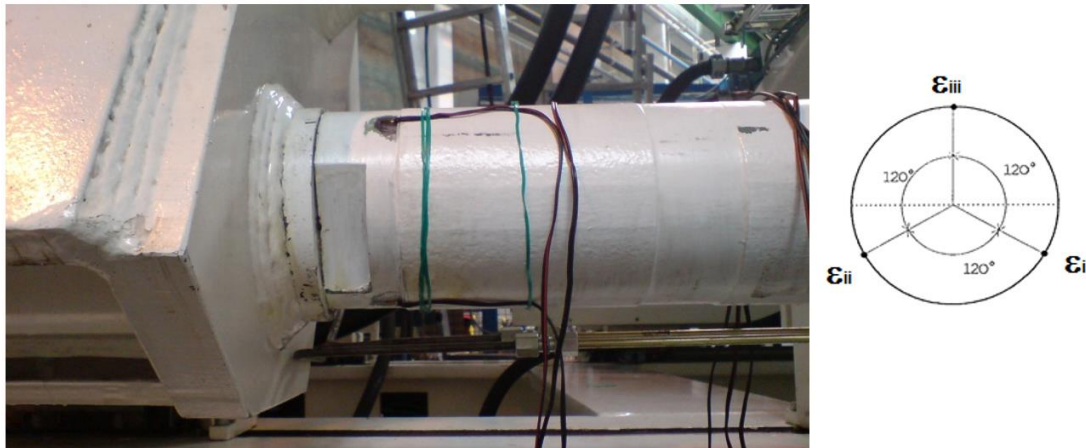
Along the critical cross-section of the guide bar, strain gauge sensors were installed at 120° spacing, so that it was possible to differentiate the effect of bending moments and normal force [10,11] (Figure 5). This procedure allowed the point of maximum cross-

Figure 5. Deployment of strain gauges along the outer cross-sectional area of the guide bar.

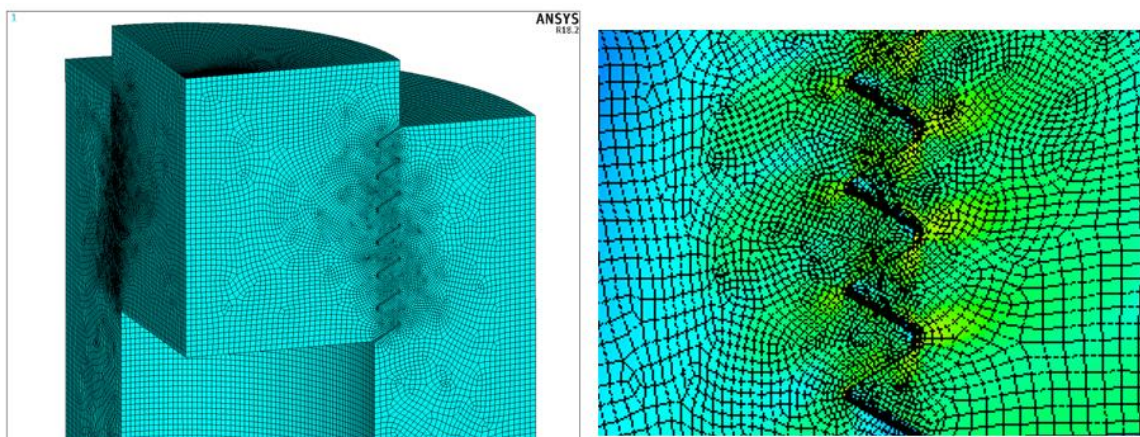
The value of the stress concentration factor K_{σ} can be determined in several ways, e.g., by using the approach of equivalent ellipse and applying the expression for an elliptical groove [6] or using the FEM model. Let us note that the usage of modeling with FEM frequently requires a careful choice of mesh, types of elements, and boundary conditions [14] (see Figure 7). When using a sufficiently fine mesh requiring as many as five elements at the thread root, a linear element (Solid 8 Node 185) could be used. At the interface of threads, an 8-node contact element (Conta 174) was employed in combination with a 3D Target 170. The setting-up of the conditions of contact and boundary conditions of the calculation was based on reaching the same stress values on the surface of the guide bar as were obtained by direct measurement. The results of the precision mathematical model of the critical node under the load of tensile force and bending moment corresponding to the measured values of stress according to Figure 6 are in Figure 8. For the value of the nominal stress from the tensile force of 40 MPa and the bending at the thread point of 30 MPa, the value of the stress concentration factor based on FEM simulation is $K_{\sigma} = 5.43$ and using Equation (3) for the notch factor is $K_{ef} = 4.4 \div 4.53$.

Figure 7. Finite element mesh at the internal M80 thread location of guide bar.

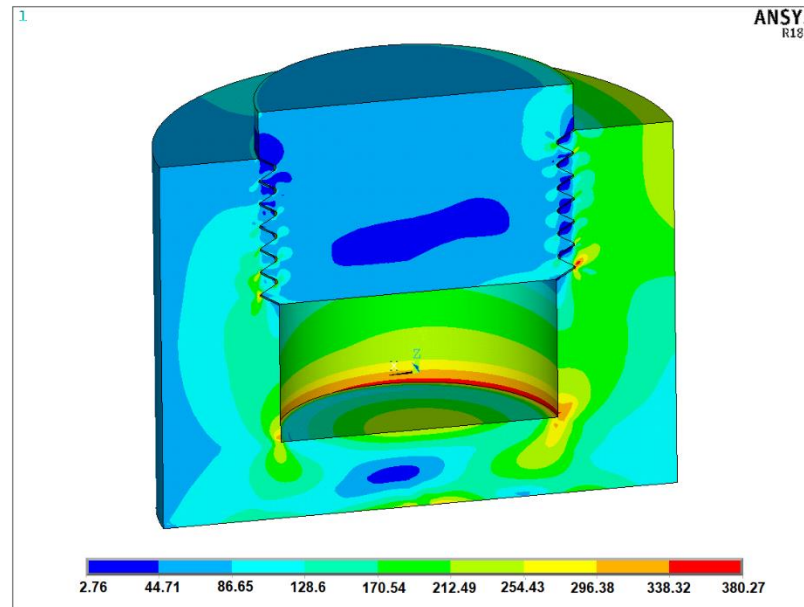
Figure 8. The resulting stresses obtained by measured values of tensile and bending loading (measured on the outer surface of the guide bar according to Figure 6).

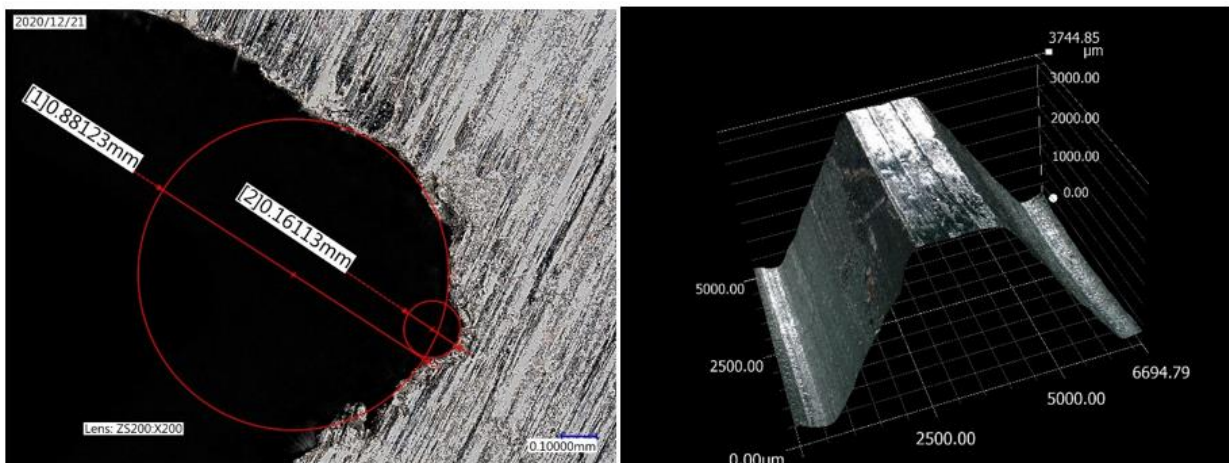
By measuring the exact geometry in the root of the thread using a digital microscope (Figure 9) and using the elliptical groove concept according to Nishida [15,16], it is possible to analytically determine the value of the stress concentration factor, $K_\sigma = 5.95$. This value is in good agreement with the results of the FEM model, which we will use in the next analysis.

Figure 9. Exact values of thread geometry obtained using a Keyence VHX 6000 digital microscope.

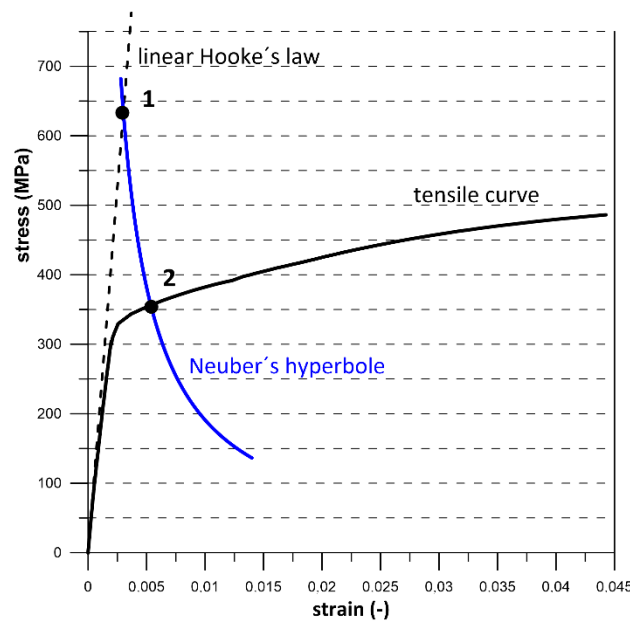
The value of the stress in the root of the internal thread is obtained by applying the Neuber method (Equation (2)). The nominal stress is based on the measured values of tensile stress (40 MPa) and additional bending stress at the thread point (30 MPa), to which the stress from the bolt pre-tension (74 MPa recalculated according to the manufacturer's data) is added. Point 1 in Figure 10 represents the stress at the root of the thread for a linear material model, point 2 for the actual tensile curve of the guide bar material.

Figure 10. Application of the Neuber method of transforming the value of the nominal stress of 144 MPa into the root of the thread (1—633 MPa, 2—352 MPa).

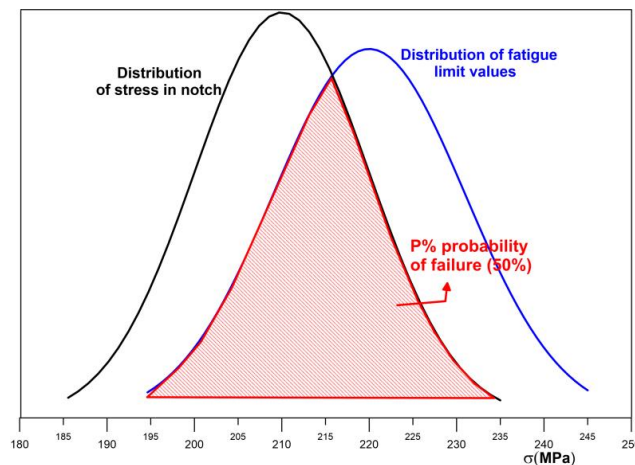
The relative position of these two statistical sets indicates the probability with which the amplitude of potential stresses in the root of the thread exceeds the fatigue strength of the guide bar material (Figure 11).

Figure 11. Statistical interpretation of the risk of early fatigue fracture for a critical location at the point of the internal thread in the guide bar of the press machine.

The situation for the numeric values specified above is graphically presented in Figure 11.

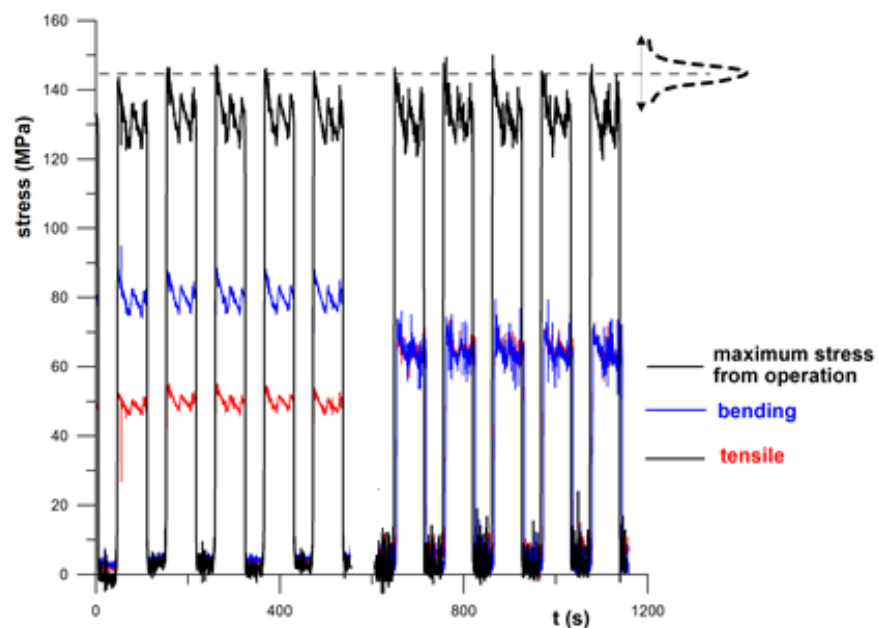
A distribution function of stress in notch (resulting from the uncertainty of designation of notch coefficient and fluctuation of the stress in the individual working cycles in Figure 12, uncertainty of notch factor K_{ef} and mean value of stress cycle taken into account based on Goodman’s [17] or Morrow’s [18] approach) is given by the following parameters of normal distribution: $\sigma_c : \bar{\sigma}_c, s_{\sigma_c}$.

Figure 12. Variability of nominal stresses (two operational modes).

where Δ is the maximal range of the stress amplitude value determined by measurement directly in operation (Figures 6 and 12) and $u^{95\%}$ is the normal distribution quantile for a 95% probability of occurrence.

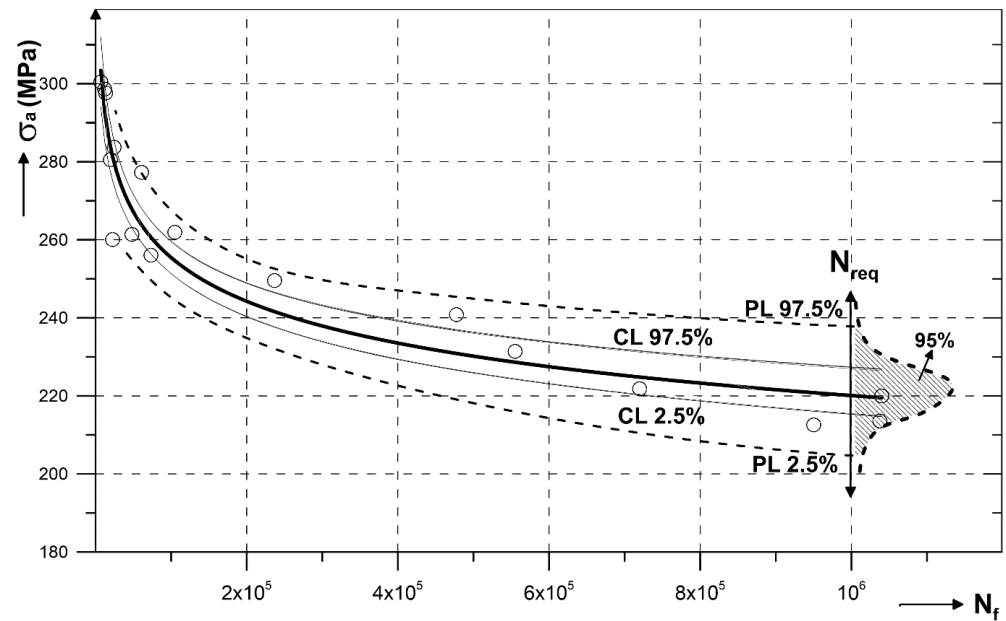
Distribution of fatigue limit values (resulting from the statistical nature variance of cyclic material properties, as documented in Figure 13): $\sigma_a : \bar{\sigma}_a, s_{\sigma_a}$.

Figure 13. Scattering of cyclic material properties on the S–N material curve described using the intervals of reliability (confidence limit—CL, prediction limit—PL).

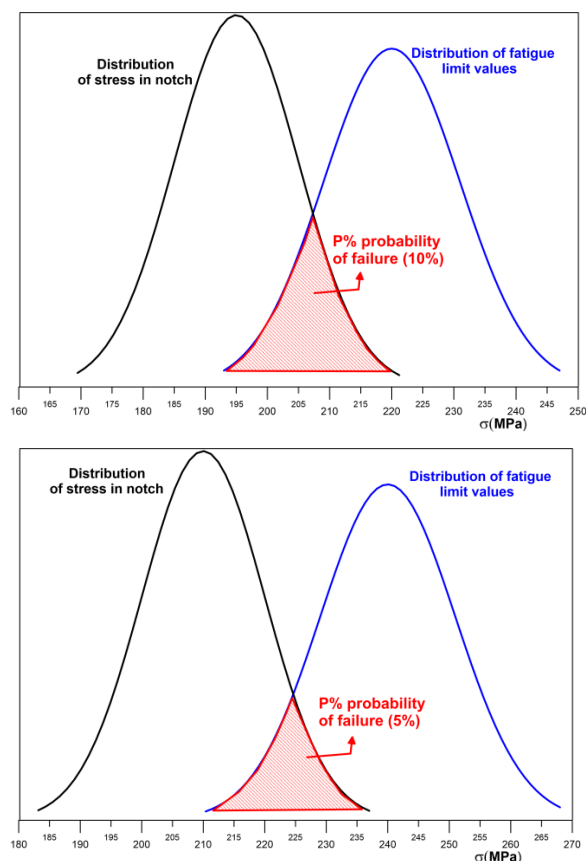
Figure 14. Graphical expression of possibilities reducing the fatigue fracture risk of press bar.

- decreasing the peak of the stress in the critical volume of material in the root of thread or
- increasing the value of the fatigue limit of material by choosing the stronger material with better cyclic material properties.

Decreasing the peak of stress in the root of the thread can only be achieved by reducing the nominal stress in the critical cross-section by reducing the pre-tension of the bolt or choosing the optimal ratio of the bolt cross-section to the annular cross-section of the guide bar at the site of the joint. The potential of these two changes is in this case a maximum of 15 MPa, which would be reflected by decreasing the mean stress value distribution in a critical place and reducing the risk of failure to 10%. By exchanging the material of the guide bar for a material with a higher fatigue limit (this step has been also done in real terms) of at least 20 MPa it is possible to reduce the risk of premature crack to a value of 5%. Those changes are graphically displayed in Figure 14.
