Integration of Remote Sensing and GIS for Modelling Surface Run-off: Case Study of Marbeea-Alshareef, Sharq Elneel, Sudan

Original Research Article

This study investigates severity of floods influencing Marbeea-Alshareef, Sharq Elneel, Sudan. The hydrological and topographical models of the area were integrated to point out the causes of the floods in the study area, along with adaptive and mitigation measures needed to avert these hazards. The integration was based on the digital elevation model. Data processing and analysis were carried out using QGIS hydrological modules and Google Earth on-line GIS facilities. Findings proved the study area is directly affected by small catchment area (182 km²) and indirectly by a large one (1386 km²). The core drivers of flooding events could be attributed to man-made features (highway and irrigation canal) and the low topography of the study area. Floods in the area can only be mitigated by establishing an efficient drainage network in the man-made features. Integration of topographical and hydrological models is important for pointing out the core drivers of flooding events.

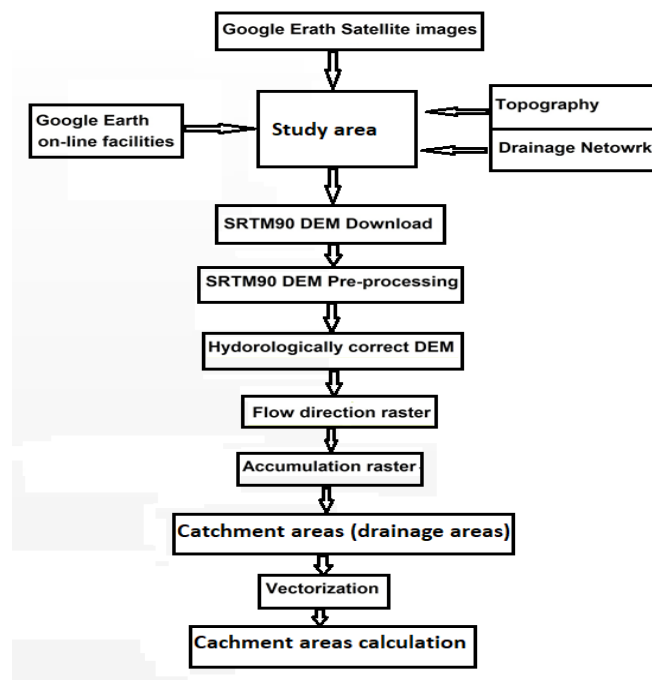
- 1- The main man-made and natural features in the area were identified using Google Earth photos and on-line GIS facilities (geographical model of the area)
- 2- The hydrological model of the area was formed using its SRTM90 digital elevation model [9] and the hydrological modules in QGIS application program, version 3.22.1 [10].
- 3- The main catchment draining areas affecting the study area were identified and their geometric information was derived (Flow chart 1).
- 4- The topographical and hydrological models parameters were integrated to answer the research question.

Flow chart 1. Data processing and derivation of the catchment areas

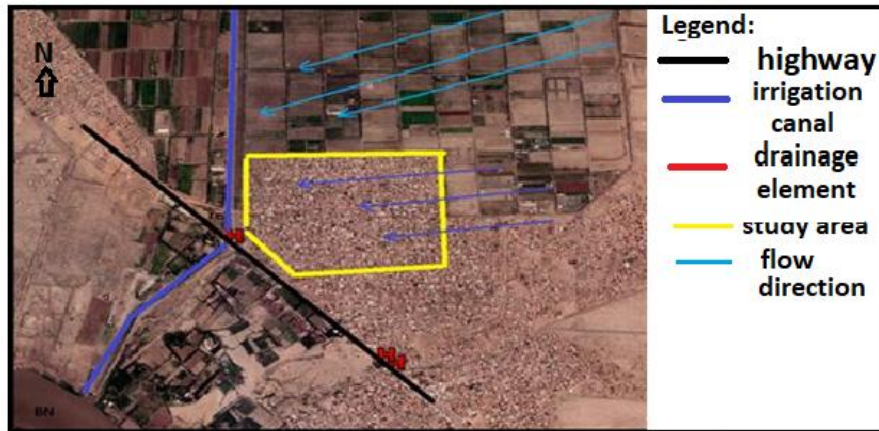
Fig. 3, clearly demonstrated that the large catchment area run-off will be blocked by the irrigation canal, back-up and flow parallel to the canal through the study area (yellow) on its way to the Blue Nile, causing flood crises. The situation even get worse when the running water blocked by the highway with an embankment 2.7 meters high, with a very limited drainage elements which are not capable of passing this large volume of water.

The draining elements in the area were explored using Google Earth on-line GIS facilities. Three elements were identified in the highway (marked red H). One large culvert (27x5 meters) and two small culverts (7x3 meters). There are no draining elements in the irrigation canal and it is surrounded by agricultural areas and has an embankment three meters high approximately (Fig. 3).

Fig. 3. The drainage elements in the study area

The large culvert was located in the highway at its intersection with the canal (Fig. 3). Fig. 5, demonstrated the strong effect of these two man-made features on the study area. As mentioned before the surface run-off from the large catchment area hits the canal and back-up following the natural drainage course in the direction of the Blue Nile. The bulk of this water

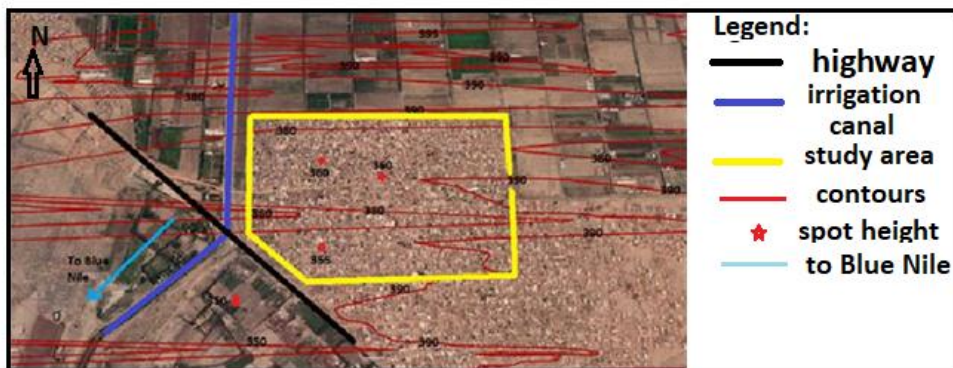
The result is that the run-off water blocked by the irrigation canal and the highway will back-up and accumulate in the low areas. As demonstrated by Fig. 4, the study area (yellow) is the lowest area

in the investigated area. This explained why the study area was the most severely affected by floods in 2007, 2013, 2014 and 2016. Normally, these floods cause a serious damage in the study area, in the form of fully and partially damaged houses and properties and losses of lives [13], [14]. However, the investigation clearly demonstrated that the floods in the study area are mainly attributed to the man-made features and to some extent to the low topography of the area. Though the study area is low compared to areas in its vicinity, it will not be severely affected by surface run-off if the irrigation canal and the highway are not present. In the absence of these features the surface run-off will follow the natural drainage course to the Blue Nile and the study area will be subjected to the small catchment area only.

Fig. 4. Google Earth topographic data of the study area

back-up again and accumulate in the low areas. As demonstrated in Fig. 4, the study area is the lowest area in the vicinity. Thus it was severely affected in all of the past floods.

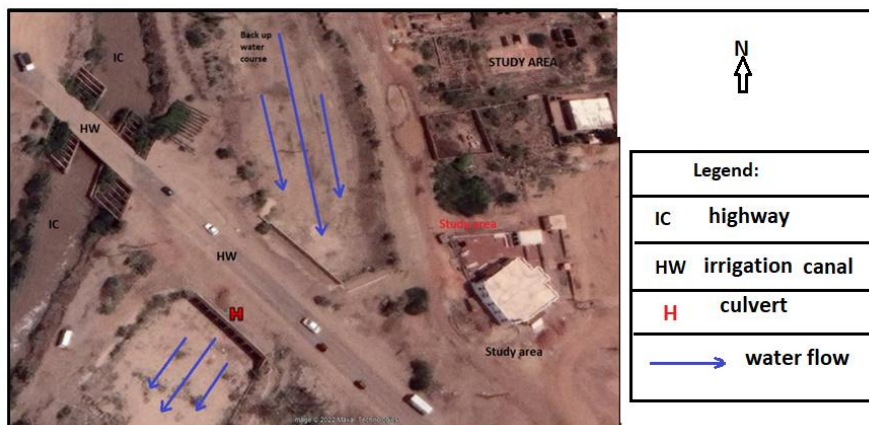
runs by the side of the canal creating a very wide (30-40 m) and deep (2-3 m) water course by erosion. This water hits the highway and accumulates due to the lack of an efficient drainage network. The result is that the water

Fig. 5. The effect of the irrigation canal and highway
